Knowing Your Guide Bands

A TOP-LEVEL REVIEW OF PROFILES, MATERIALS AND PROPERTIES

Research and Development

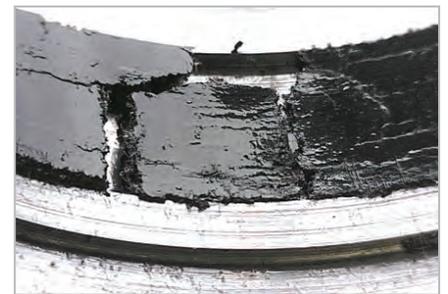
Right top: This image shows a center fracture failure in a guide band made of a Phenolic material in a convex contoured ring shape.

Right bottom: This image shows fatigue cycle failure in a flat-shaped guide band. Fracturing is from the use of Phenolic material that can be brittle.

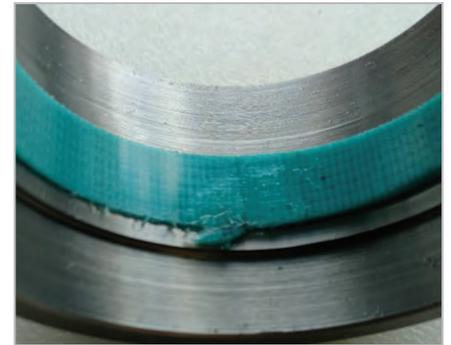
Delamination is the separation of layers in composite materials, often caused by repeated cycle stresses. Delaminated guide bands lose significant mechanical toughness and can ultimately fail.

Many lesser-quality polyester guide bands have been found to delaminate over time. Delamination is a failure mode in composite materials when layers begin to separate. This can be caused by repeated cycle stresses and lead to significant loss of mechanical toughness. System Seals' new custom formulations are designed and tested specifically to prevent delamination.

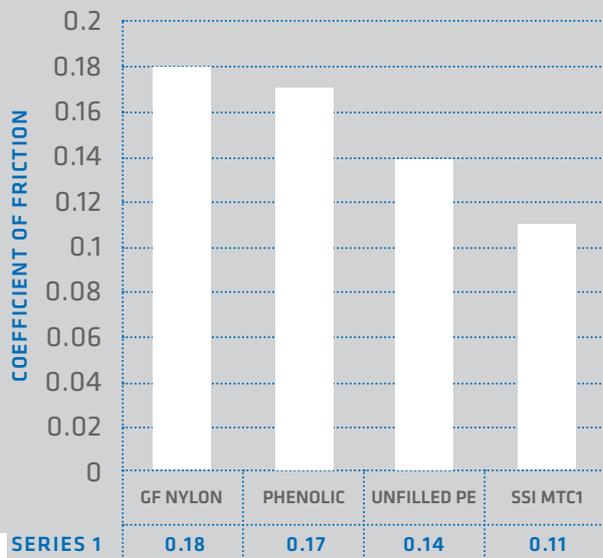
DYNAMIC COEFFICIENT OF FRICTION

The research project recorded wear rates and coefficients of friction. The tables below show the respective properties for four popular guide-band materials.

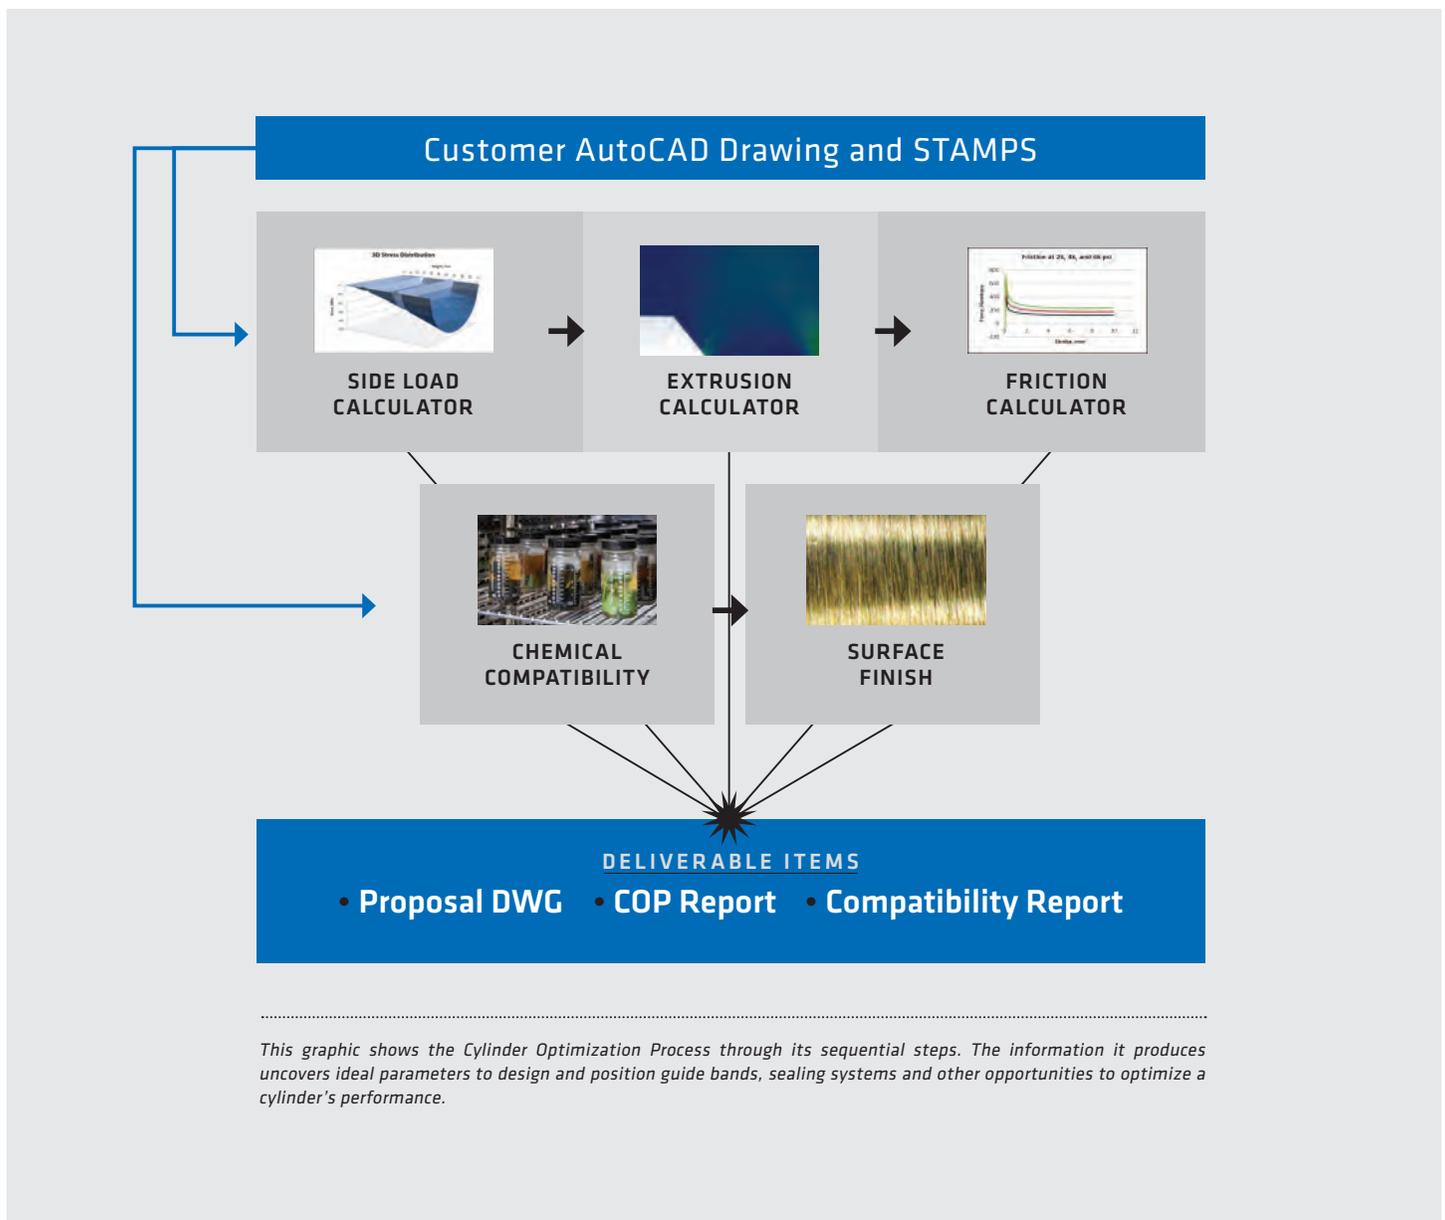
This graphic shows the Cylinder Optimization Process through its sequential steps. The information it produces uncovers ideal parameters to design and position guide bands, sealing systems and other opportunities to optimize a cylinder's performance.

System Seals' Research & Development Lab has created new mathematical tools that take the guesswork out of cylinder performance. These tools calculate precise levels of side-load, friction and the potential for seal extrusion.

The process uncovers unique data points that enable engineers to design guide bands and sealing systems in ways that optimize a cylinder's performance and reliability. Some customers have saved millions of dollars using System Seal's analytic tools, while finding hidden potential to extend uptime, reduce risk and increase productivity.
